*This presentation is for illustrative and **general** educational purposes only and is not intended to substitute for the official MSHA Investigation Report analysis nor is it intended to provide the sole foundation, if any, for any related enforcement actions.*

ACCIDENT DESCRIPTION

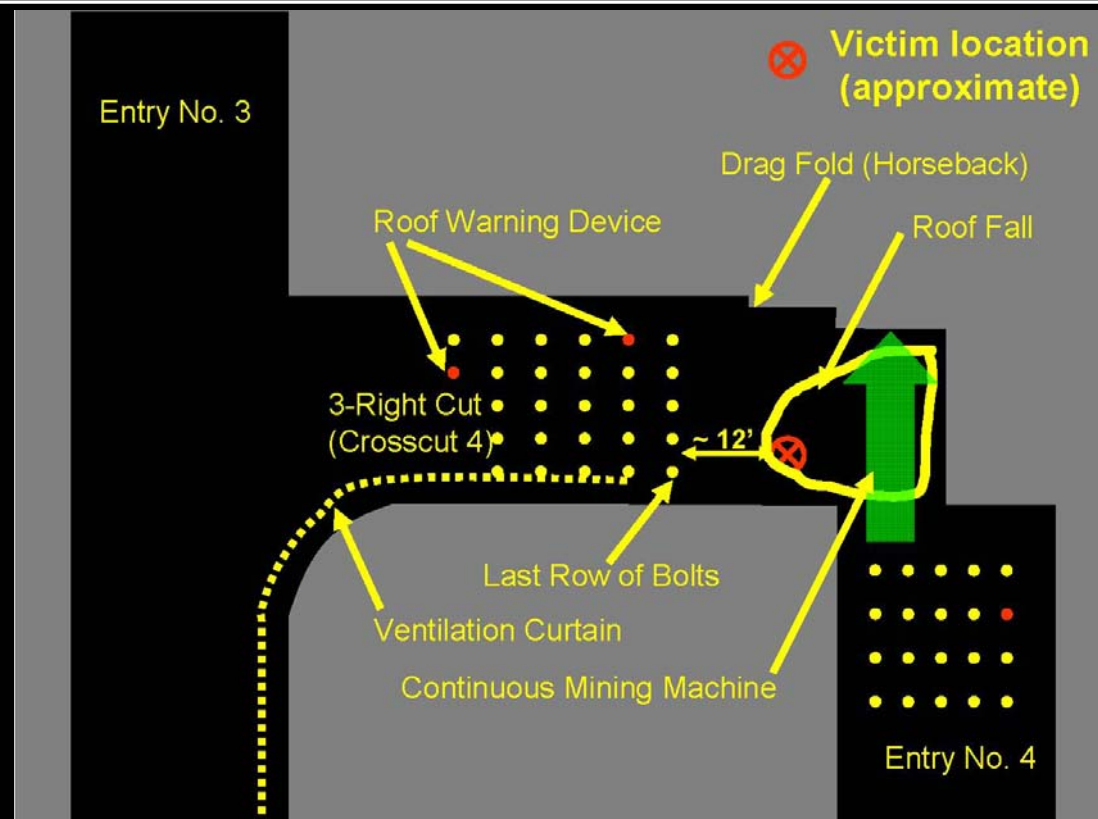
On Monday, June 6, 2005, second shift miners entered the mine and performed normal mining activities. While mining entry No. 3, a geologic fault and drag fold were encountered that produced excessive amounts of water from the roof and floor. This water flowed outby and into the 3-Right working place, accumulating in the unbolted area mined during the previous cut. The bolting crew entered the 3-Right working place and installed three rows of bolts. They did not bolt the remainder of the cut because water had accumulated near the face. This left an unsupported area approximately 16 feet long and 21 feet wide.

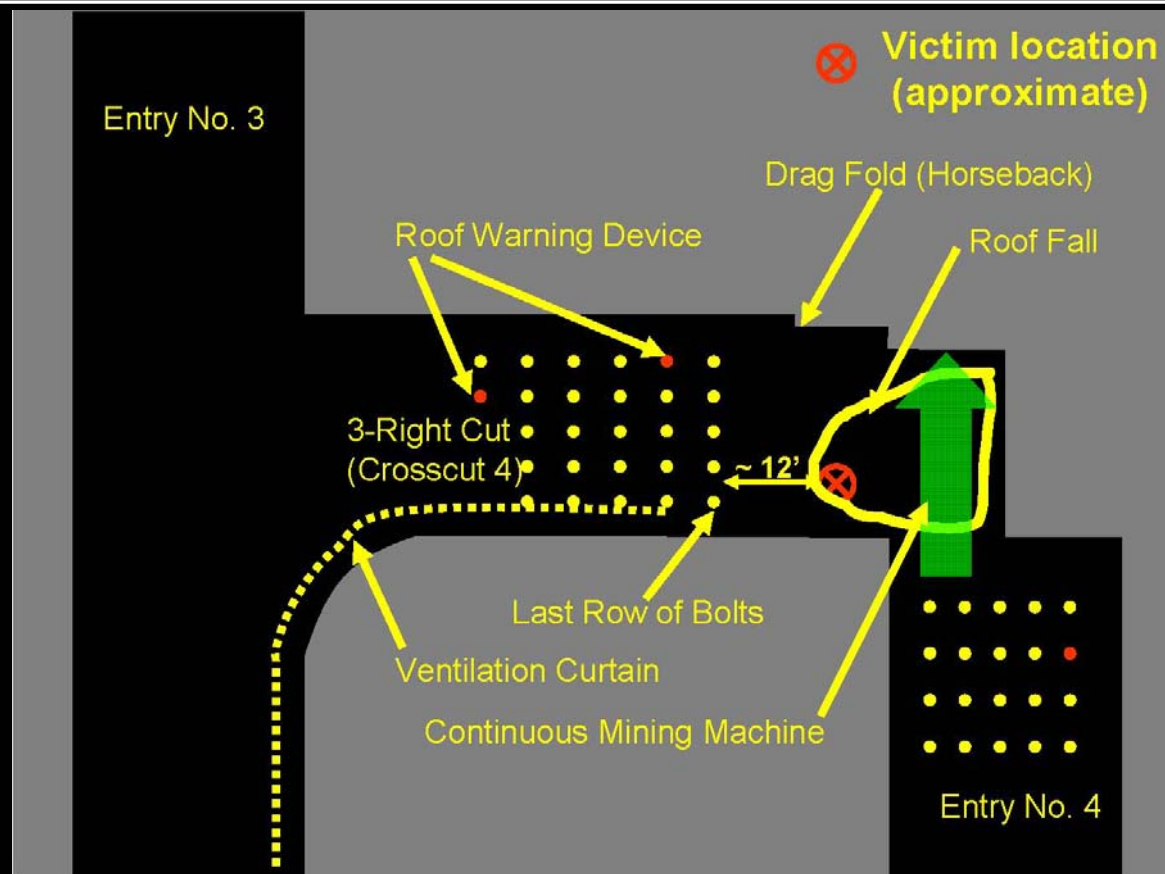
While entry No. 4 was mined, the victim, who was an electrician, performed duties as helper on the continuous mining machine. When the working face of entry No. 4 was cut into the unbolted area of the 3-Right cut, water flowed from the face. The victim left the area, traveled outby around the pillar block and into the unbolted portion of 3-Right. At that time, the left lift of the No. 4 entry was completed. As the continuous mining machine was backed out of the cut, portions of the immediate roof fell, which covered and fatally injured the victim.

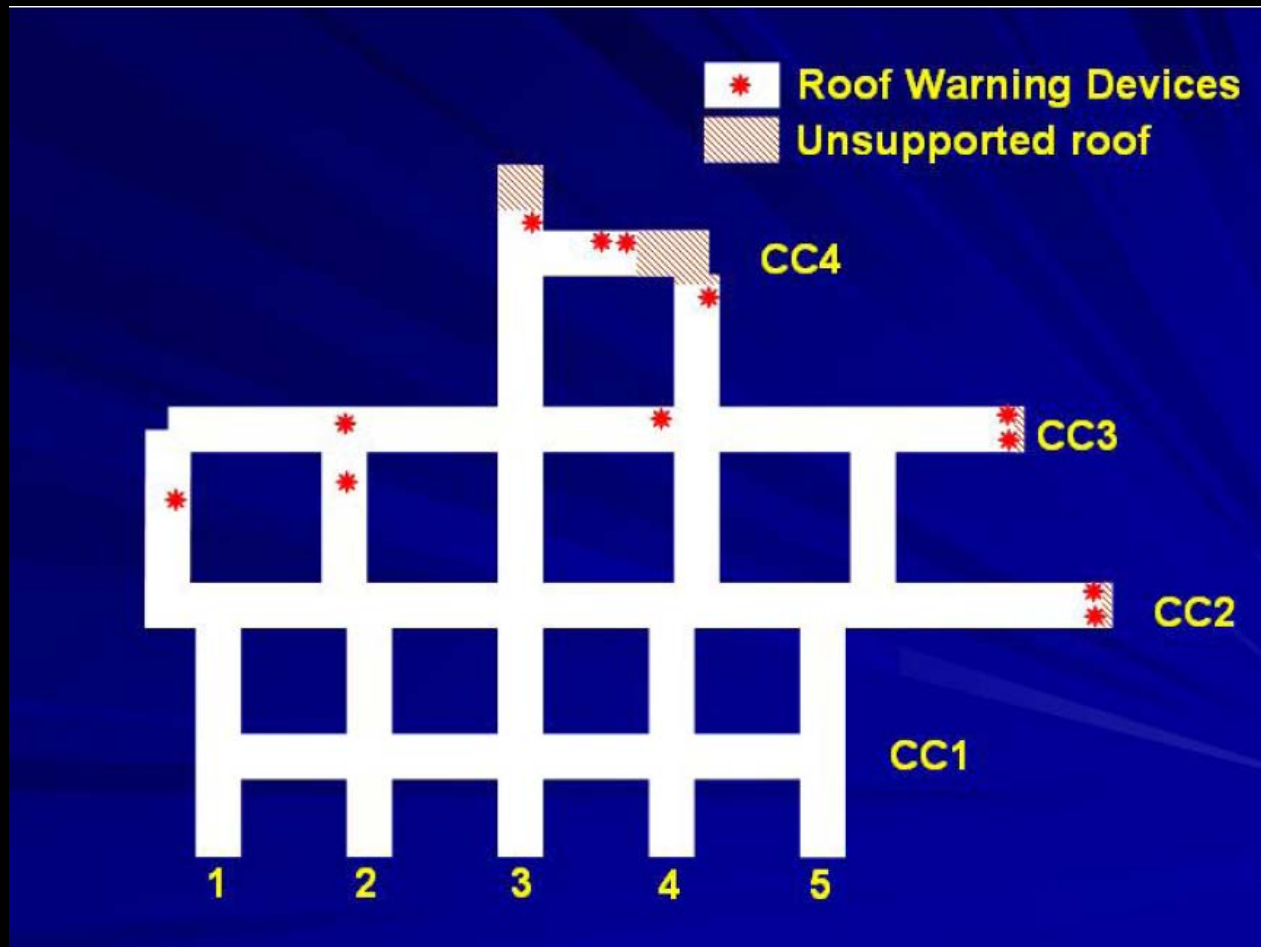
A reflective warning device was installed on the next to last row of roof bolts on the left side of the entry in the 3-Right accident area. At the time of the accident, a ventilation curtain was hung from the roof near the right rib in 3-Right, which provided blowing ventilation for the mining and roof bolting operations in the crosscut.

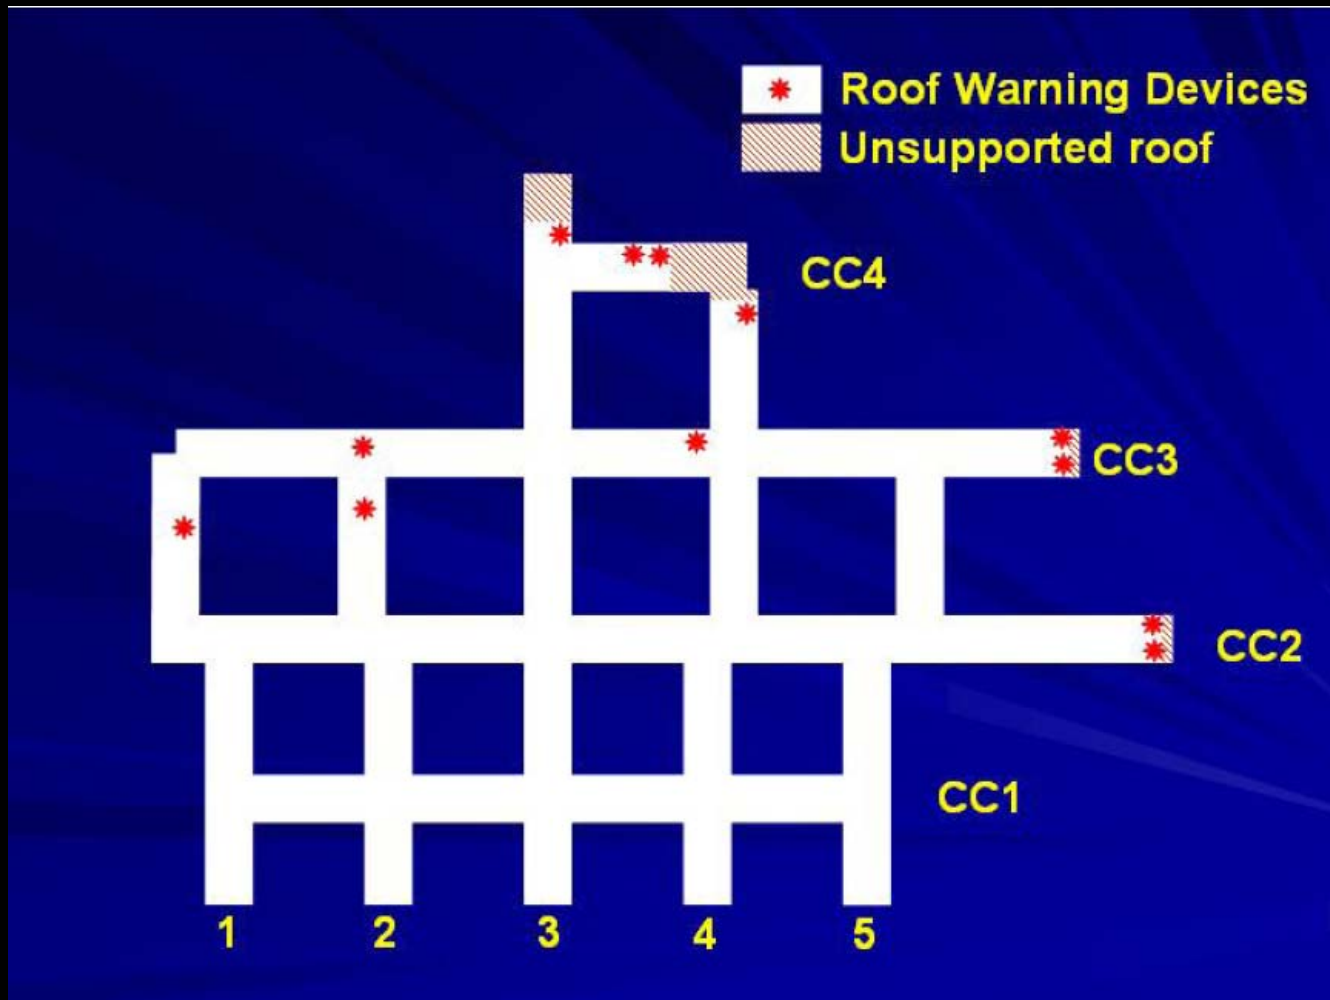
Although the investigation could not determine the victim's route of travel, he may have walked between the curtain and the rib when he entered 3-Right. Thus, the curtain would have obstructed his view of the reflective warning device located on the left side of the crosscut.

c) Depending on his route of travel into 3-Right, which could not be determined during the investigation, he may have walked between the ventilation curtain and the right rib. Thus, the curtain would have prevented the victim from seeing the reflective warning device that was hanging from the roof on the left side of the crosscut.

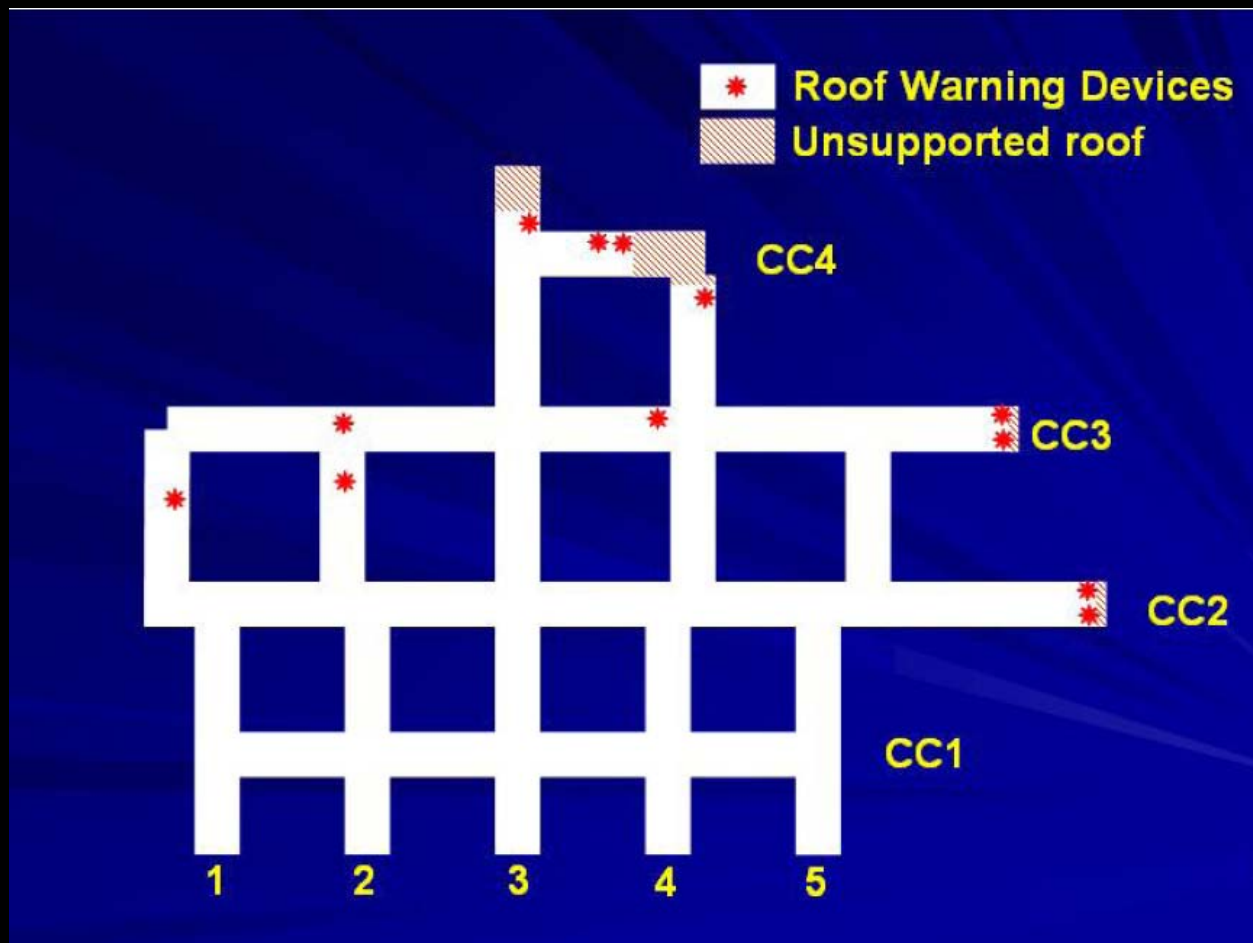
Also, in 3-Right just outby the accident area, a second roof warning device was installed on the left side of the place, five rows outby the last row of permanent roof supports. This placed two roof warning devices in the same crosscut with the second one approximately 16 feet outby the one on the next to last row of bolts.

d) An extra roof warning device was located outby in 3-Right at the accident site, which, depending on his route of travel, may have confused him as to the proper location of the end of permanent roof supports or caused complacency as to the use of these warning devices.

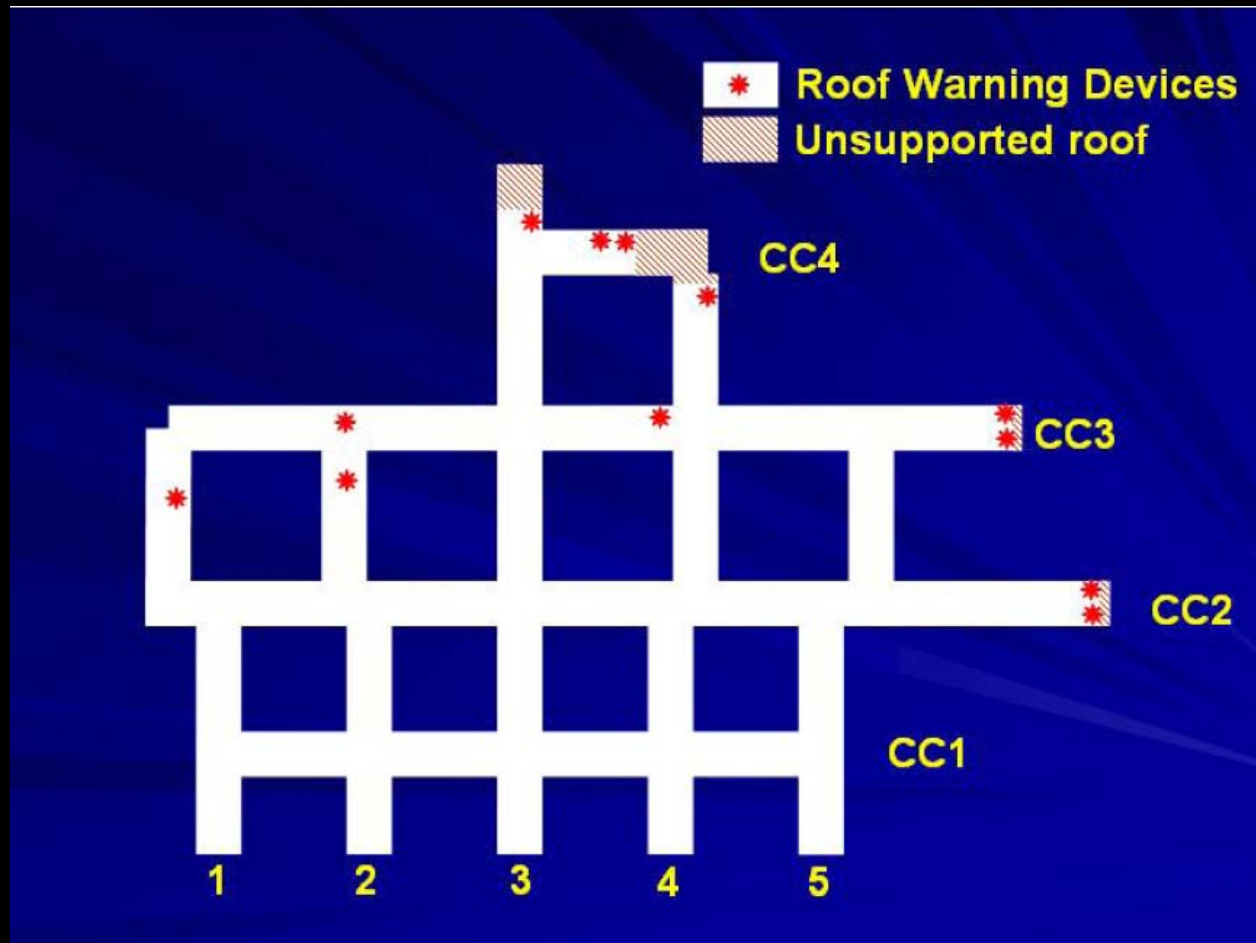
The section had four other roof warning devices hanging in areas that were not near the last row of permanent roof supports. These extra warning devices defeated the intent of the warning system, potentially caused confusion, and promoted complacency as to the proper location of the end of permanent roof supports.
